# A pictorial essay of breast implant imaging and implant complications

*Ann. Ital. Chir.*, 2016 87: 493-501  
pii: S0003469X16026087

Gozde Arslan\*, Levent Celik\*\*, Rahmi Cubuk\*\*\*

KEY WORDS: Breast, Implants, MRI, Rupture

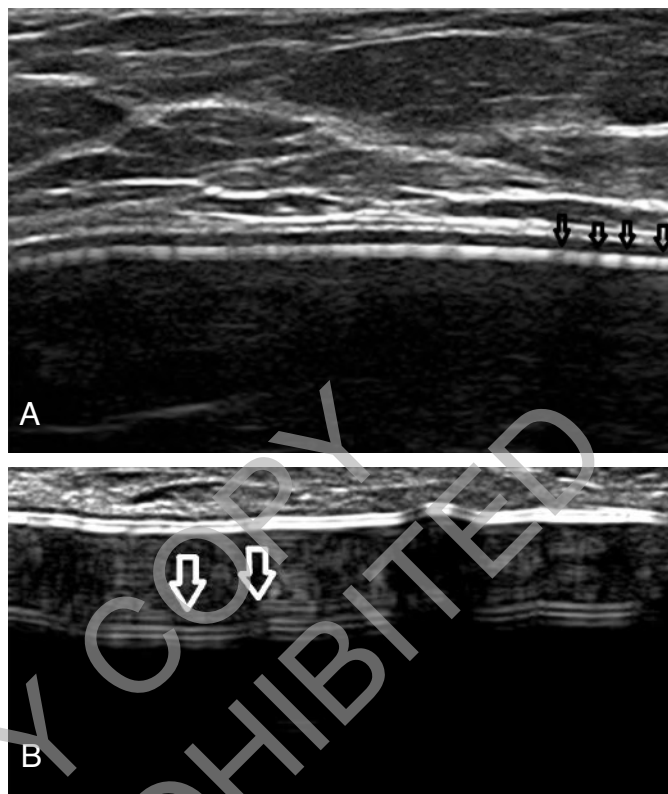
Fig. 5: A) Sonographic images of textured, B) smooth implants. Textured implant and tiny posterior acoustic shadows on posterior membrane. Smooth implant and prominent reverberation artefact.

This is the first modality of choice due to its ease of access and applicability. It is performed in the supine or oblique position using a 7-12 mhz linear transducer. The implant material is sonolucent. Based on our experience, textured and smooth shell implants can not be differentiated on mammography and MRI but may only be differentiated on sonographic imaging. (Fig 5A-B). Textured implants have multifocal tiny posterior acoustic shadowings on inner membrane whereas smooth implants have a smooth outer membrane but a prominent reverberation artefact. To the best of our knowledge; there is no literature about this differentiation. On US, reverberation artefact is observed between the capsule and neighbouring breast tissue (Fig. 6).

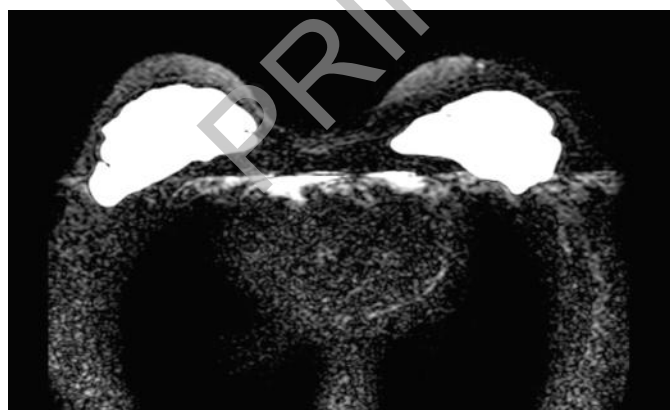
Fig. 7: Axial section, silicone only MRI sequence. Only silicone appears hyperintense and all other structures are suppressed-hypointense.

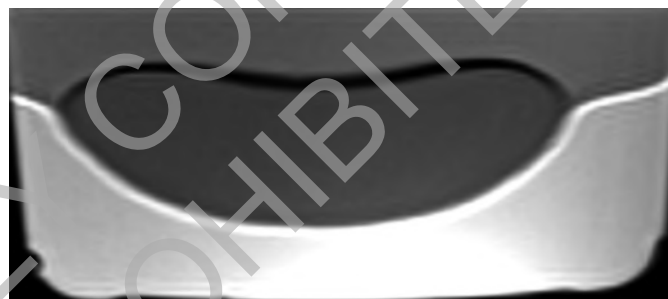
Fig. 8: On T2 FSE MRI sequence. Water is the brightest object.

We have created phantoms for major MRI sequences of implant imaging. We have put liquid oil and water inside the phantom and we have inserted silicone implant in the middle.

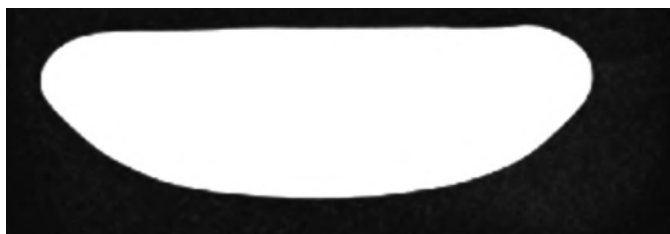
Fig. 11: On stir+ water sat T2 sequence silicone is the brightest object. This is the silicone only sequence that is used on modern mri devices.

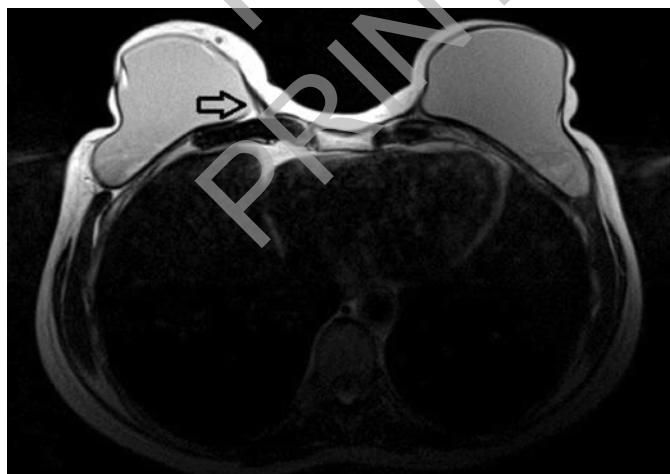
Fig. 12: Axial section, T2 tse MRI sequence. There is minimal free fluid neighbouring the right implant.

Minimal peri-implant fluid collections are frequently observed and accepted as being normal. It occurs secondary to an inflammatory reaction to the implant. It is generally small in amount. It may cause pain if there is a fast increase in fluid. It is observed as hypoechogenicity neighbouring the implant on US or hyperintensity on T2WS MRI images (Fig. 12). The fluid is clear and there is no accompanying fibroglandular inflammation. It can be aspirated if it is infected or causes pain.

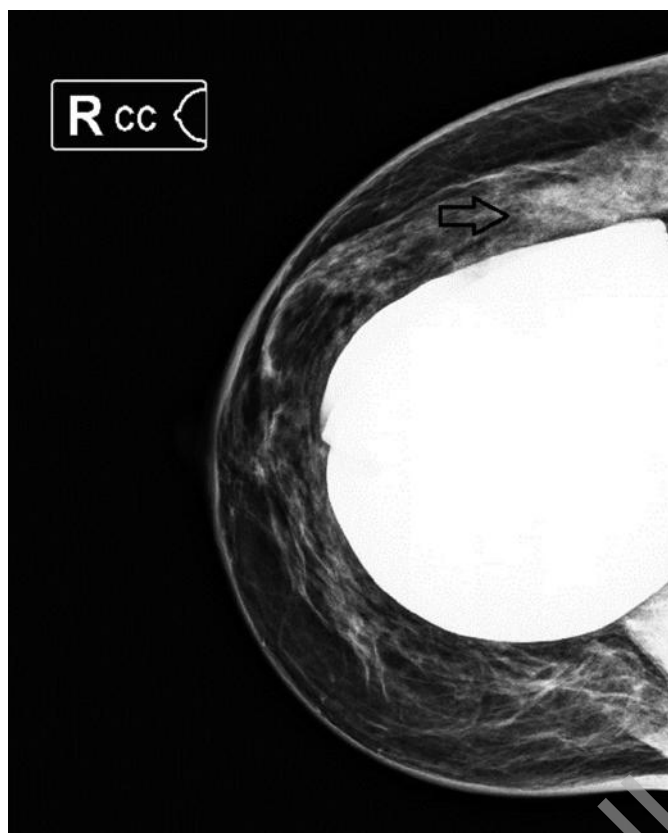
Fig. 15: Right MLO mammography. High density patchy areas are seen superior to the silicone.

a high density area surrounding the silicone (Fig. 15) and the hematoma is demonstrated by MRI as hyperintense on precontrast T1 series and hypointense on silicone only sequence. Hematoma may be overlooked if T1WS is not imaged (Fig. 16).

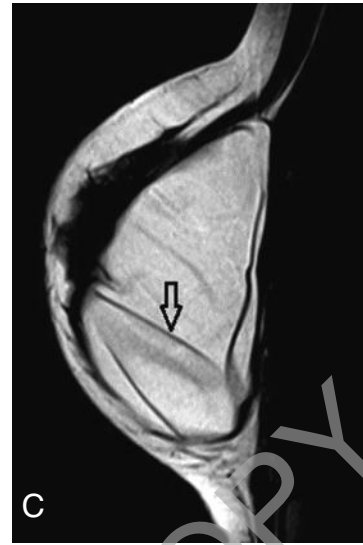
Fig. 18: A) Linguine sign suggestive of intracapsular rupture can be seen within the left breast implant on axial plane silicone only sequence. B) Keyhole sign observed within the left implant, suggestive of intracapsular rupture. C) Wavy line sign is seen within the left implant, suggestive of intracapsular rupture on sagittal section, non fat sat T2WS MRI.

Intracapsular rupture is best seen on MRI. Some signs on MRI are suggestive of intracapsular rupture. Linguine sign, key hole sign and wavy line sign are some of these. The linguine sign demonstrates the free floating membrane within the silicone (Fig. 18A). The key hole sign is the appearance of the separated inner membrane resembling a key hole (Fig. 18B). The wavy line sign is similar to the linguine sign. It is due to the freefloating

of part of the inner membrane in the silicone (Fig. 18C)<sup>15</sup>. In intracapsular ruptures, the silicone extravasates between the fibrous capsule and the outer cover of the implant, leading to expansion of this space. Progression may lead to extracapsular rupture.

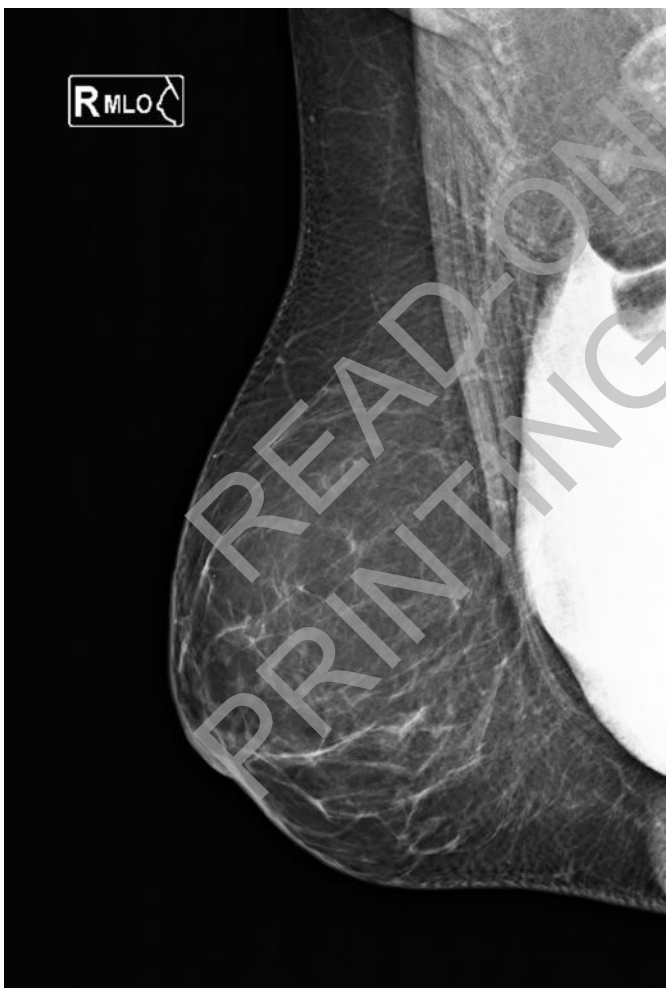
Fig. 19: Right MLO mammography. Compatible with extracapsular rupture

b) Extracapsular rupture: It is the macroscopic leakage of the silicone outside the capsule. The extravasated silicone leads to inflammatory reaction and the formation of foreign body granuloma. On mammography, the hyperdense silicone is easily seen outside of the breast tissue (Fig. 19). Sonographically named as “snowstorm sign”, echogenic nodules with a clear anterior border yet vague acoustic shadowing on the posterior are detected. This is due to the extravasation of silicone outside the capsule (Fig. 20). Diagnosis is best

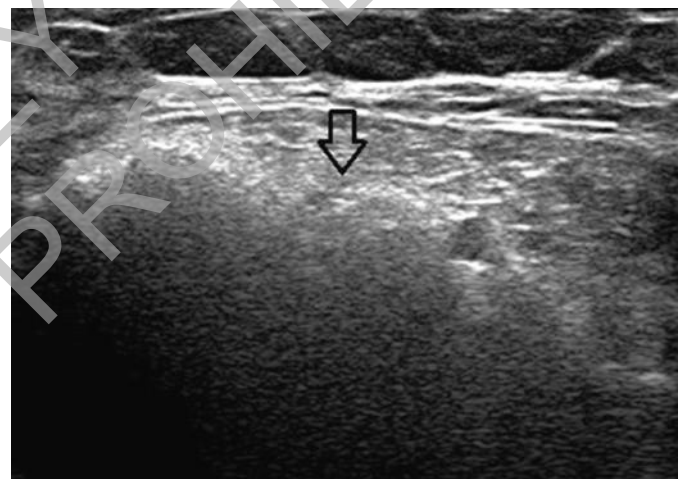
Fig. 20: US image demonstrating posterior artefact of silicone extravasation outside of the capsule to the right axillary area.
